Manhole Inspection Summary

Manhole # S15E1_002MH

Insp Date: **5/23/08 10:38 AM**

Location Address: **3031 james st**

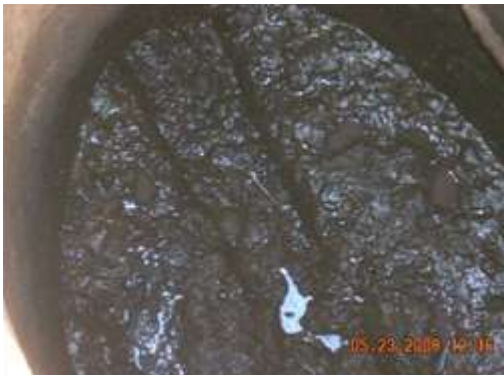
Defect 4

Condition: ☐ Sound ☐ Cracked ☐ Root Intrusion ☐ Deteriorated ☐ Leaks ☒ **Debris**

debris in channel

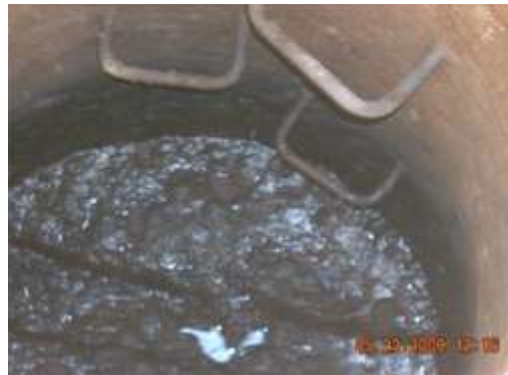
debris on bench

Condition: ☐ Sound ☐ Cracked ☐ Root Intrusion ☐ Deteriorated ☐ Leaks ☒ **Debris**

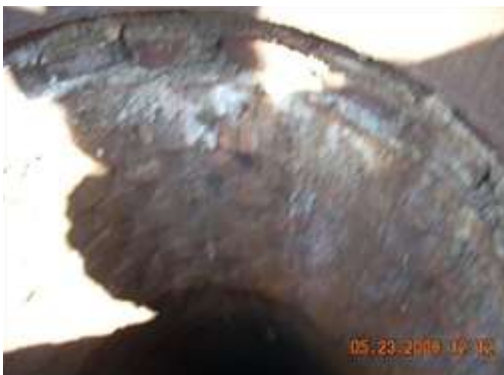
Defect 2

Infiltration: ☐ None ☒ **Joint** ☐ Cracks ☐ Mortar ☐ Roots ☐ Wall

infiltration @ chimney/frame joint

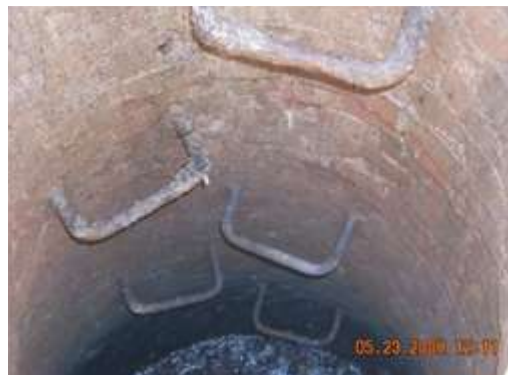
Defect 1

Count: **5** Missing: **0** ☒ **Corroded**

corroded steps

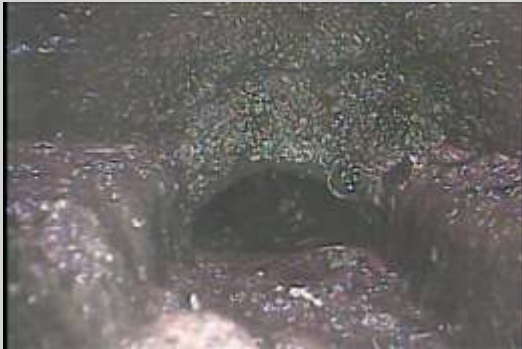
12 O'Clock Outflow

Deposits: ☐ None ☒ **Mud** ☒ **Sludge** ☐ Debris ☐ Grease

Silt Depth: **4** (in.) Deposits Extent: **Heavy**

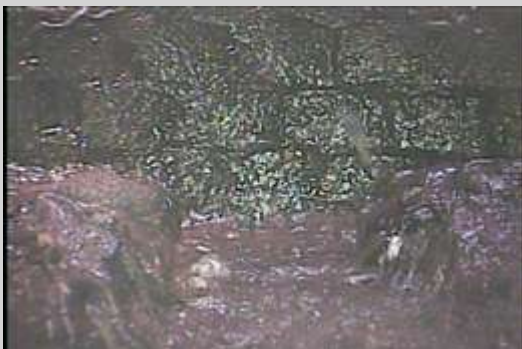
6 O'Clock Inflow

Deposits: ☐ None ☒ **Mud** ☒ **Sludge** ☐ Debris ☐ Grease

Silt Depth: **6** (in.) Deposits Extent: **Heavy**

Connects To: **Stub connection / abandoned**
